Manhole Inspection Summary

Manhole # S37U__018MH

Location Address: **R. 1611 Light St**

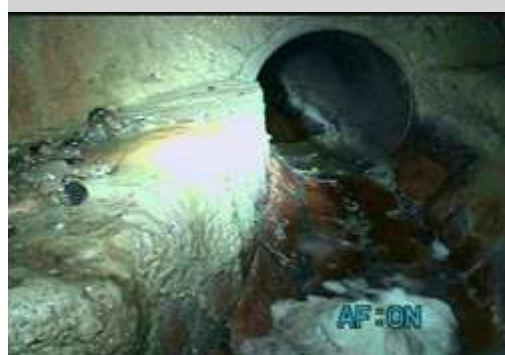
Defect 3

bench debris

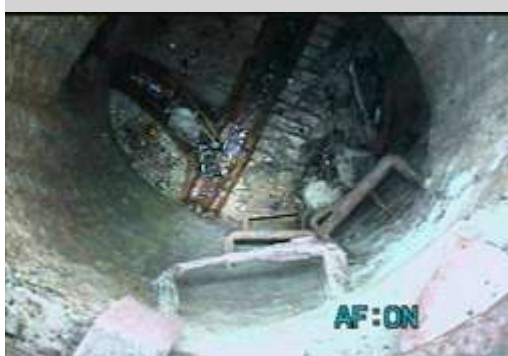
Defect 1

steps corrosion

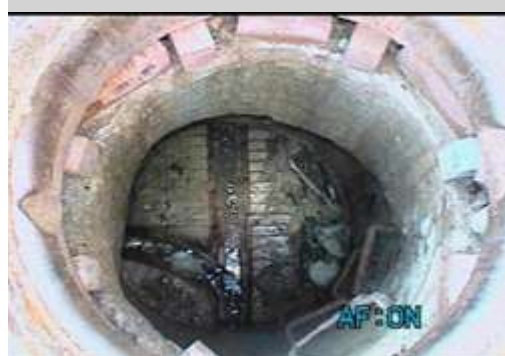
Defect 3

Condition: ☐ Sound ☐ Cracked ☐ Root Intrusion ☒ Loose Brick ☒ Deteriorated

chimney deteriorated

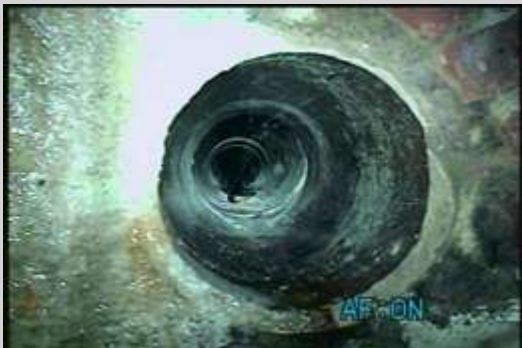
3 O'Clock Inflow

Drop In @ 3 O'Clock

Drop: Outside Direct

Drop Condition: Open
